Failure Estimation of the Majdanpek Open Pit East Face Based on Inverse Velocity Model | Miloš Marjanović, Stefan Milanović, Nikola Simić, Lazar Kričak | Regional Symposium on Landslides in the Adriatic-Balkan Region, Belgrade, 15-18th May 2024 | 2024 | |

Failure estimation of the Majdanpek open pit east face based on inverse velocity model

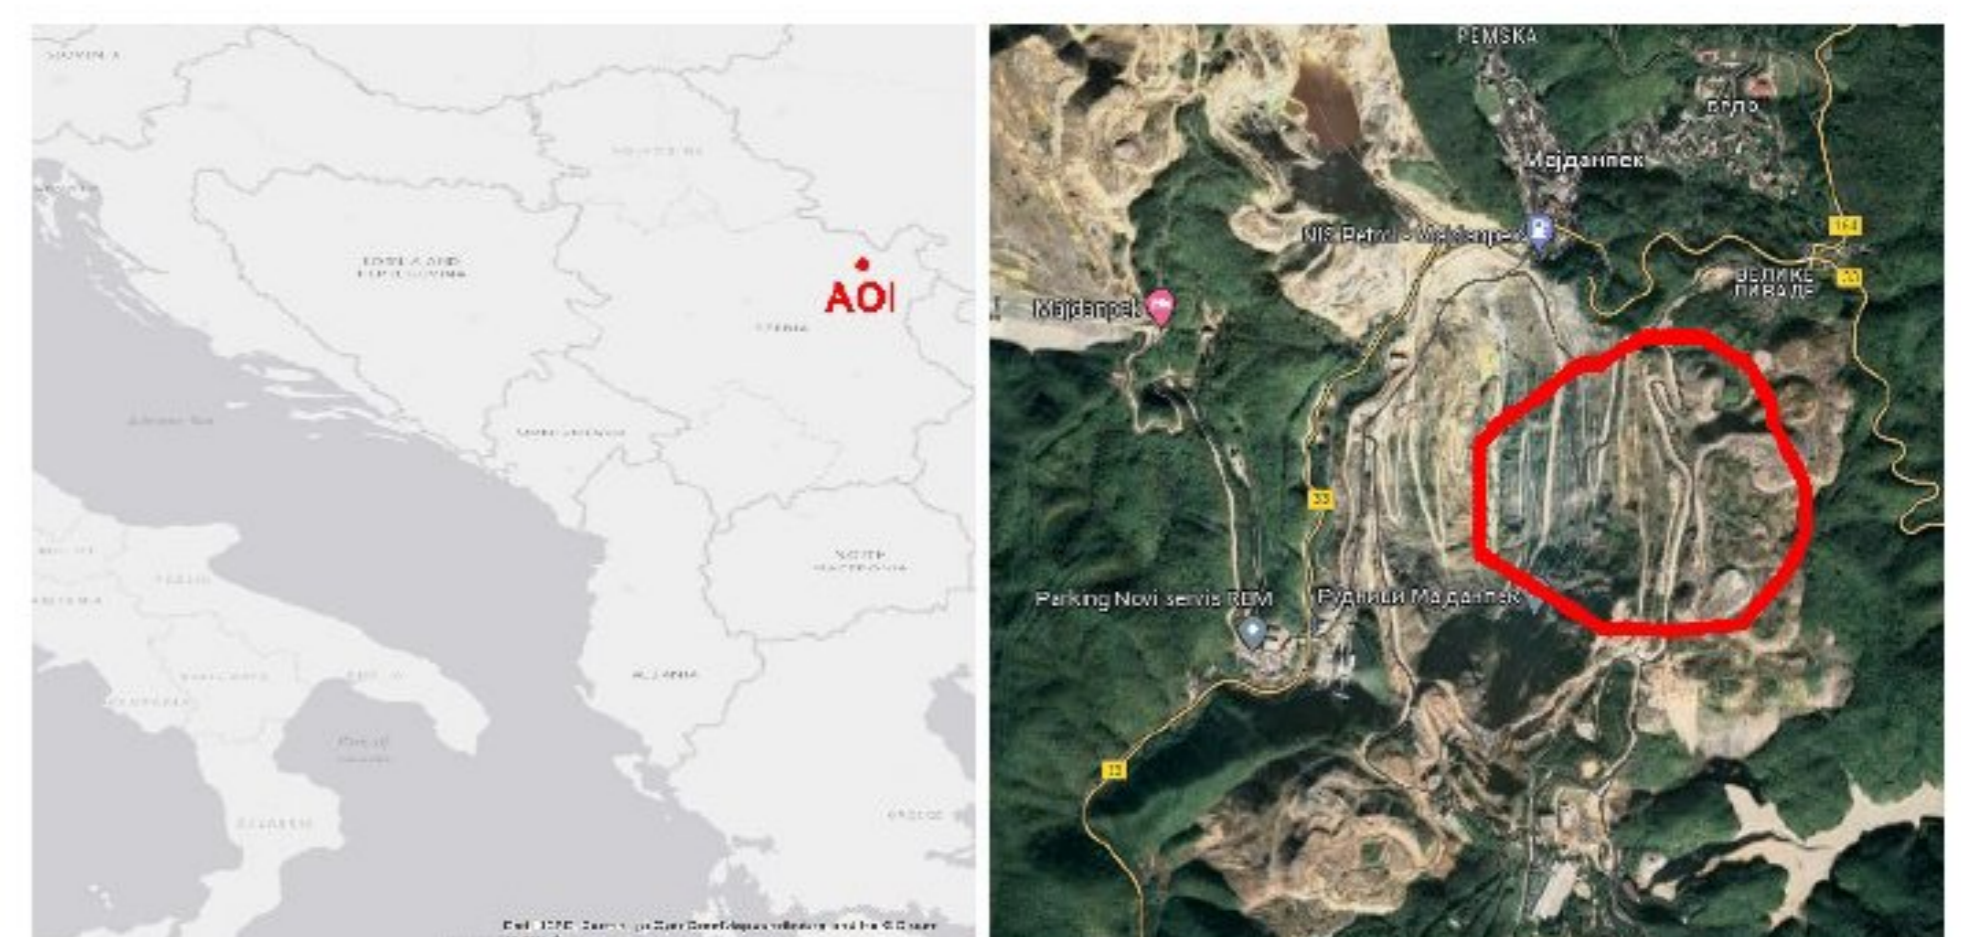
Figure 1 Plan view of the Majdanpek south district open pit (red).

The Majdanpek south district open pit mine (Fig. 1), one of the many in the realm of eastern Serbia copper mines is located within the outskirts of the Majdanpek town. The Pek River crosses through the upper horizons of the pit, as well as the regional road No. 33. After more than 60 years of exploitation, the current pit elevation is at about 100 m ASL and its crest at 620 m ASL suggests that it is soon to be approaching its terminal depth of 550 m, as further deepening is considered a bad practice, both economically

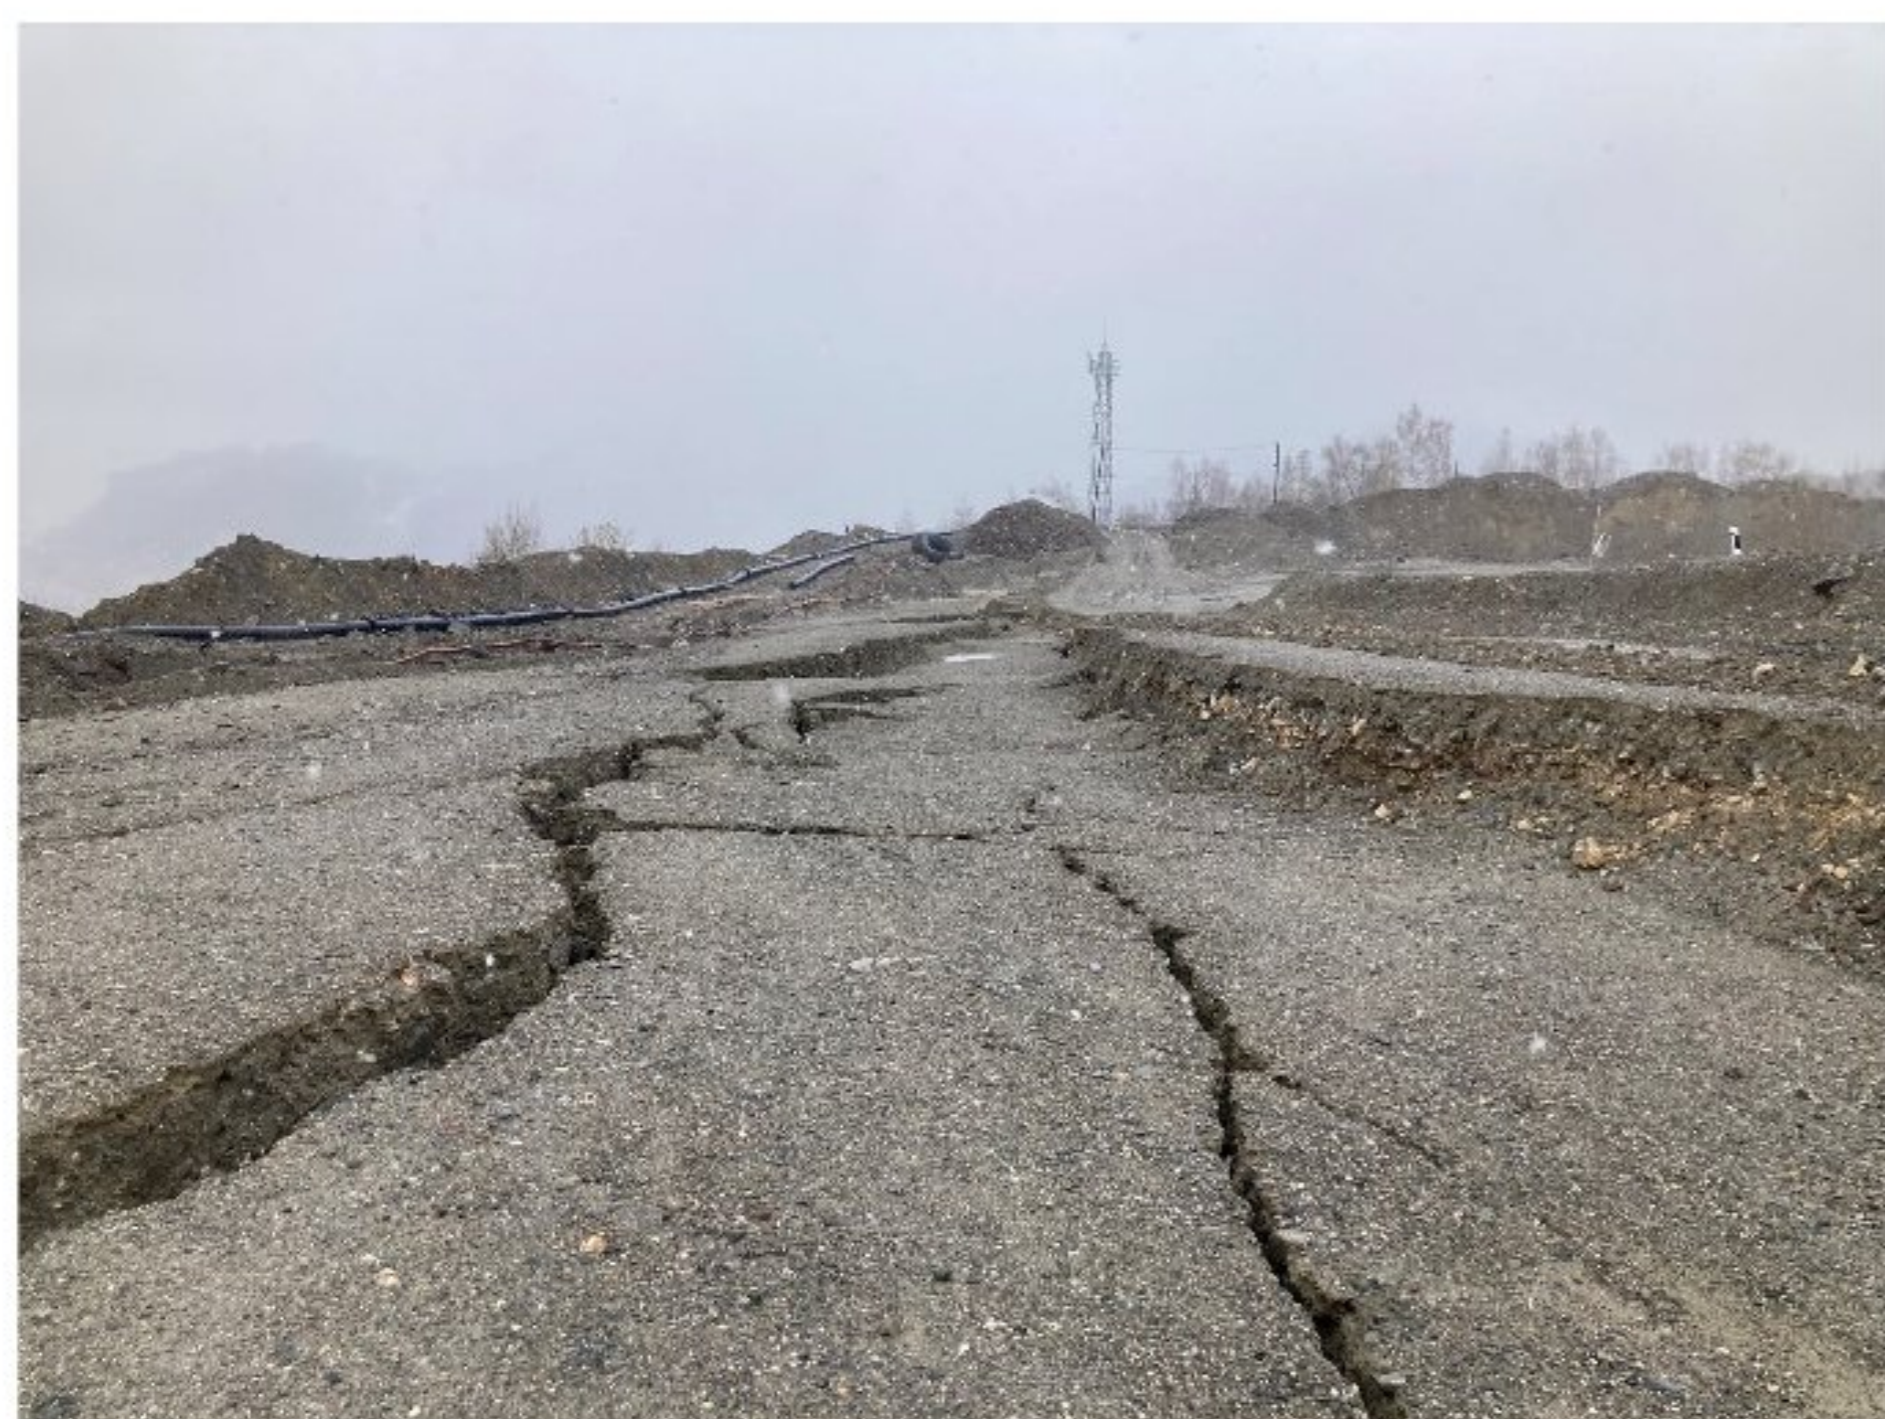
Figure 2 Gapping cracks and local benching between conjugated failure planes on the abandoned tailing horizon 550 m.

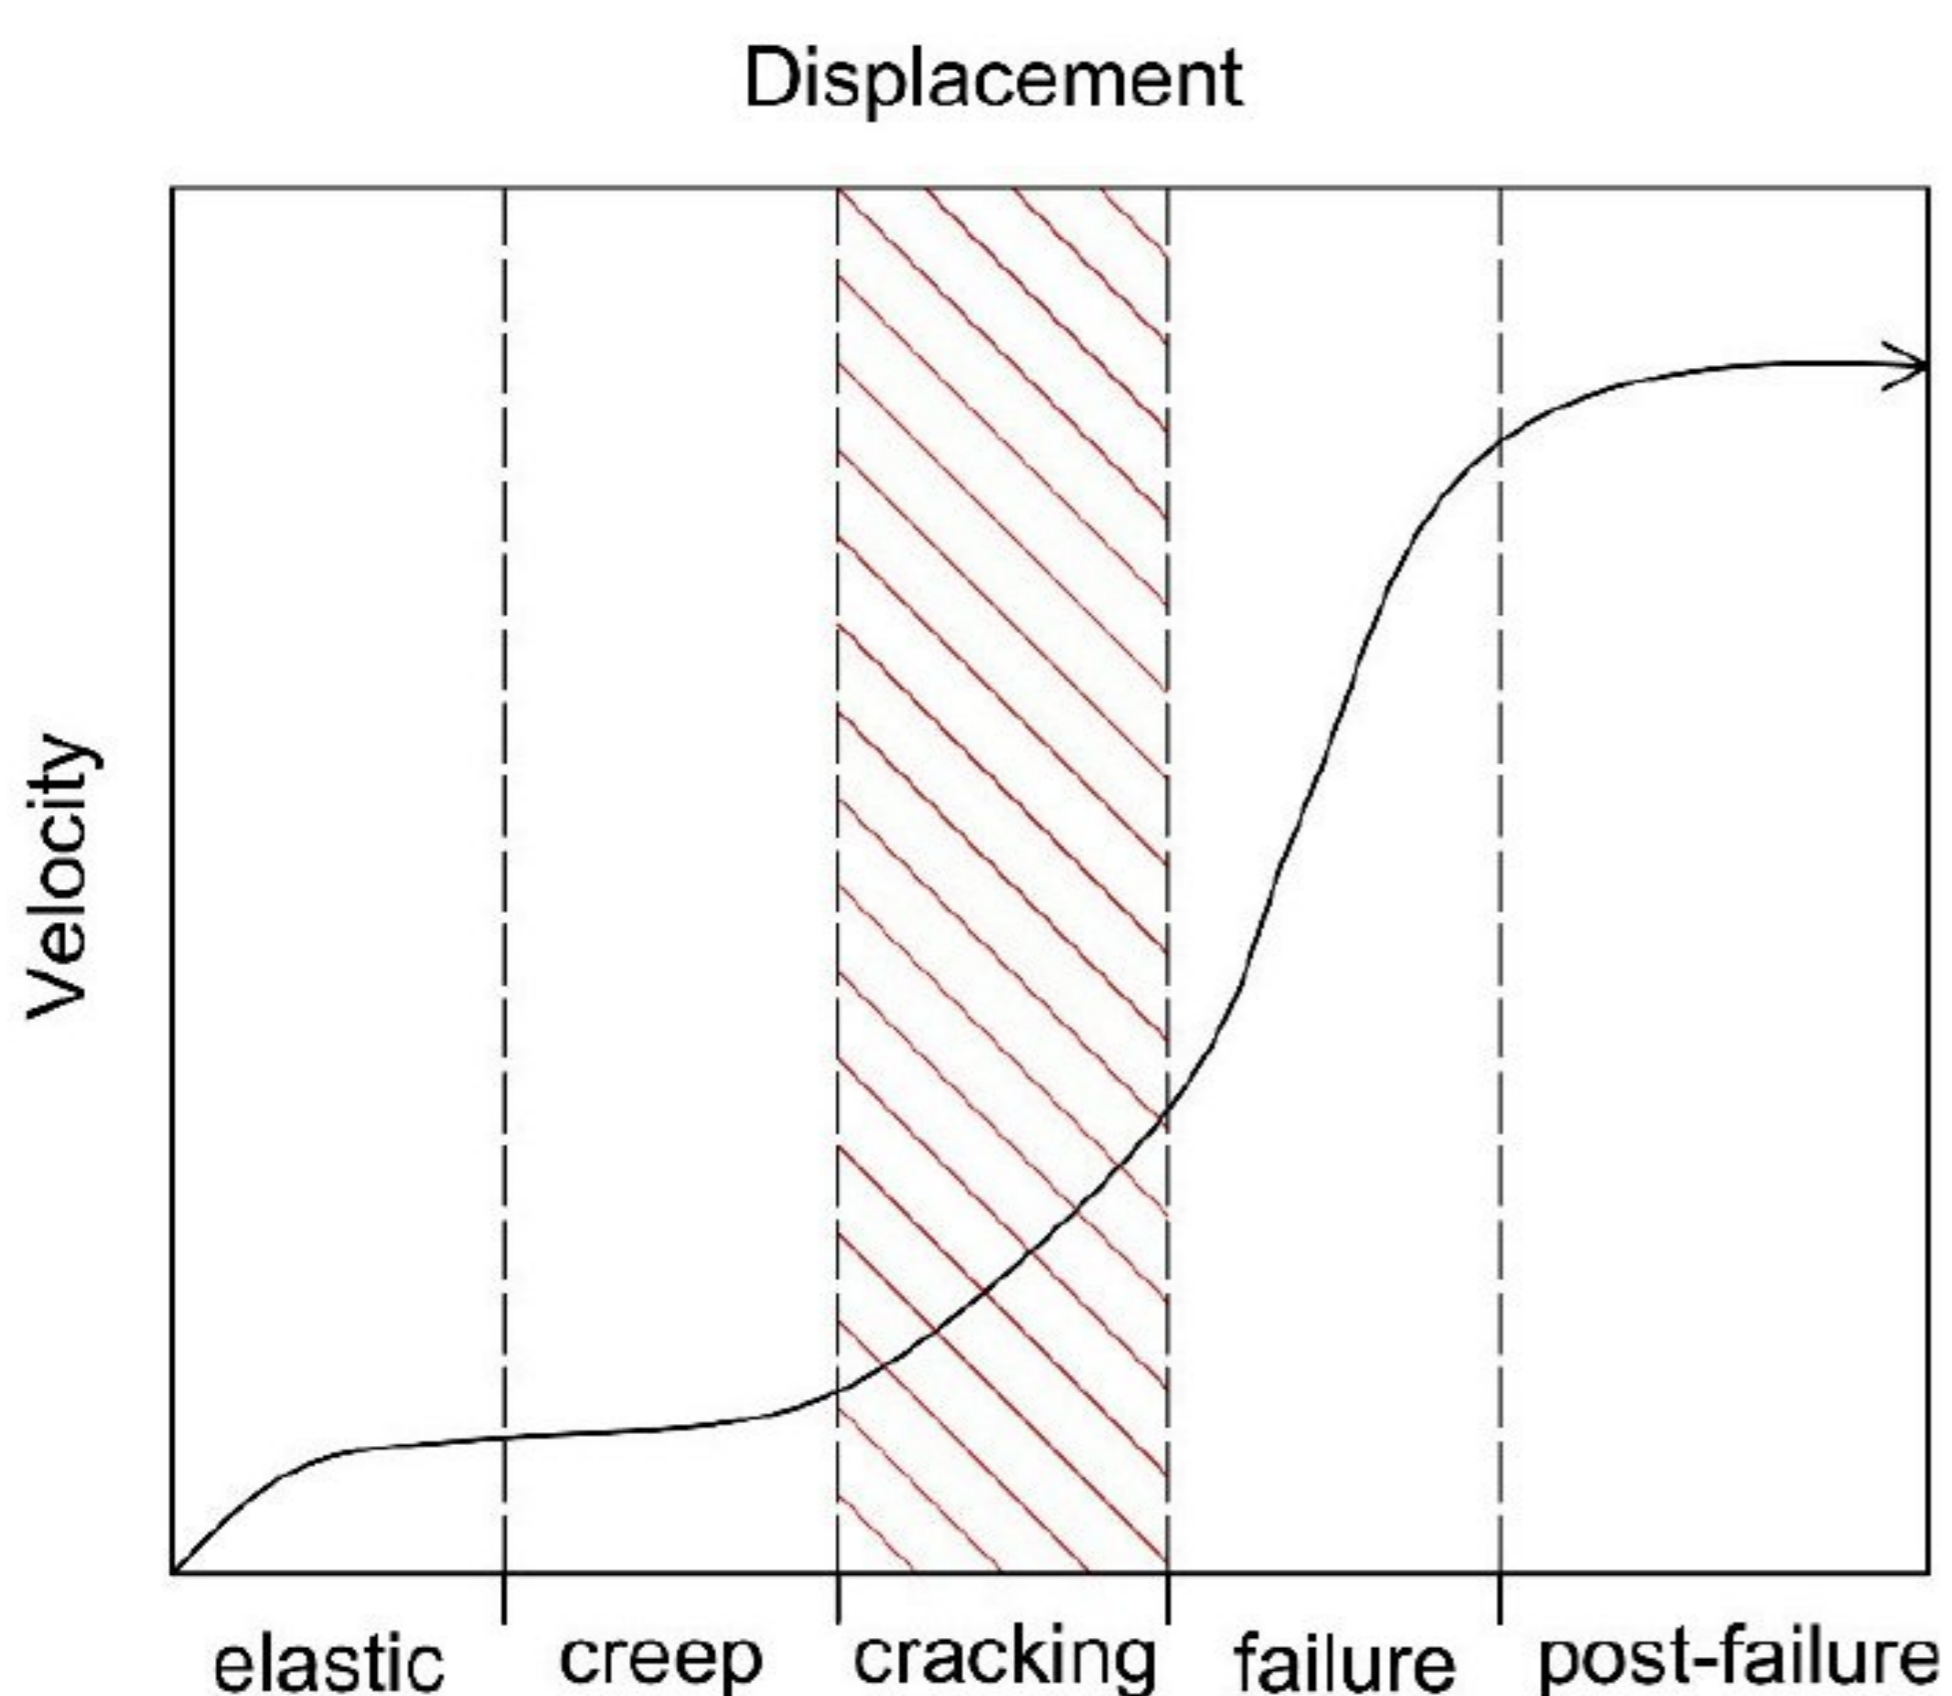
Figure 3 Schematic progressive failure curve and phases of deformation, with current slope state (shaded area).

Management of landslides, especially at the open pit slopes require constant displacement monitoring, to avoid any incidents that might affect staff and equipment. Cumulative displacements, with appropriate frequency of measurements, are one good indicator, but assuming the stage of the curve is difficult in an on-going survey. The same applies for velocity derived as displacement per temporal frequency of measurements (mm/day), although acceleration and deceleration phases can be recognized. An alternative is to use inverse velocity, i.e., temporal frequency vs. displacement (day/mm) as its threshold cut-off is zero, when theoretically the velocity of failure approaches infinity. Once day/mm trend is established (usually following the linear fashion) it is possible to linearly extrapolate the trend and determine the time when it will reach zero, i.e., the moment of failure.

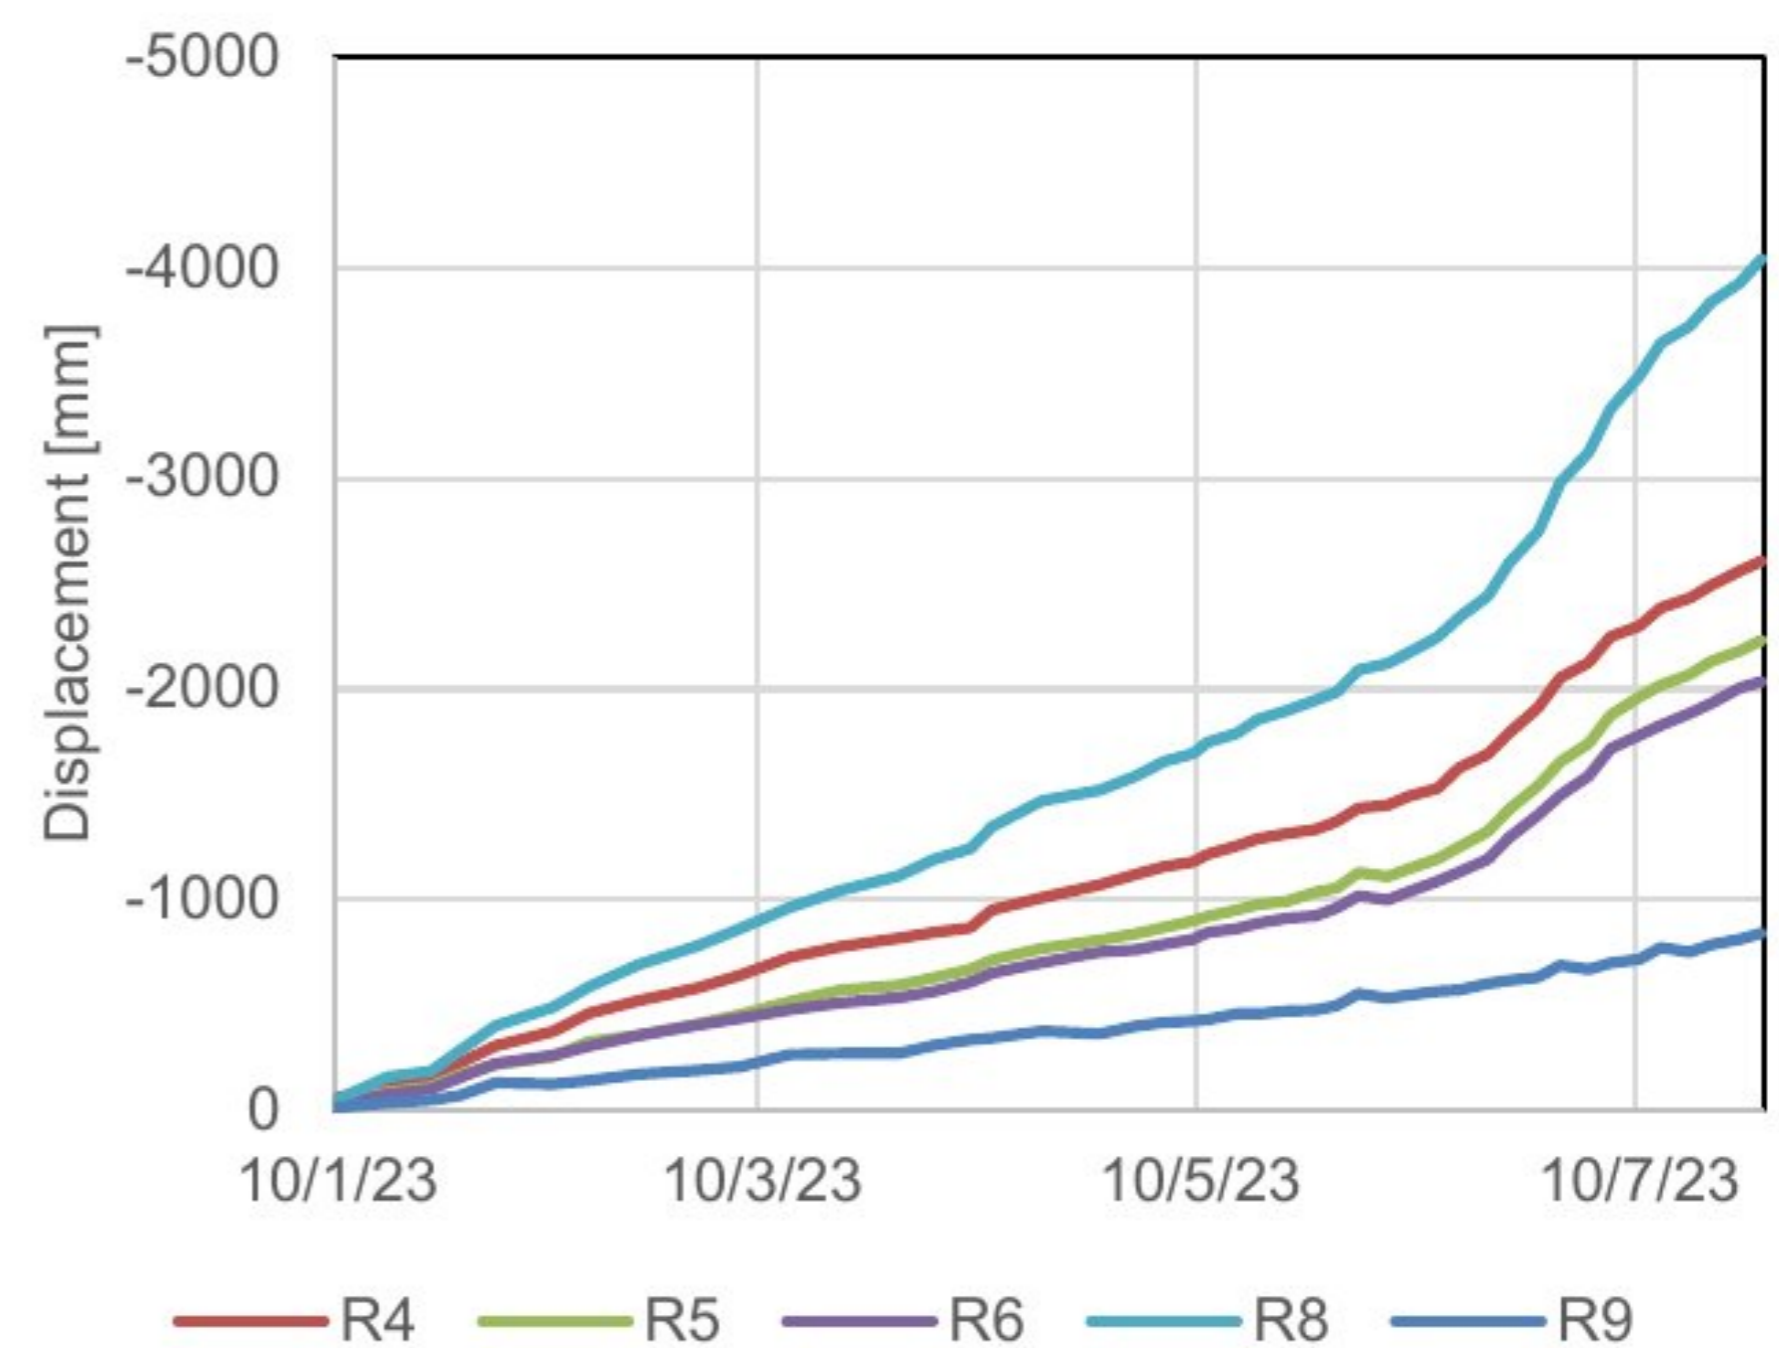
Figure 5. Cumulative vertical displacement for Jan-Jul 2023 on benchmarks R4-9.

Cumulative displacement suggests that there are periods of acceleration and deceleration, which are synchronized across all benchmarks (Fig. 5), indicating that global failure is possible, and that inelastic creep is in progress. Displacement rate is the highest in benchmark R8, reaching 60 mm/day. Smaller accelerations were obvious in Jan-Feb (ranging between 10-20 mm/day), and Apr-May (ranging between 20-30 mm/day), while the most prominent one is in Jun-July (ranging between 30-40 mm/day). In between, the displacement rate is constant at about 5-10 mm/day. Such rate corresponds to Slow to Moderate landslides according to conventional classification (Hung et al., 2014), while in domestic mining legislation they can be considered level 4 of 5, which is an alerted stage, just before immediate actions.

Displacement rates are calculated for Northing, Easting and Z directions and total vector. Given the slope orientation, the total horizontal vector more-or-less coincides with westward movement. Therefore, the most interesting are findings for -Y and -Z (vertical) directions. The inverse velocity linear trends (Fig. 6) are suggesting that the creep is still not in the final acceleration phase, as the trend gently declines towards the horizontal axis for all benchmarks. Benchmark R9 is showing biased values as it has both uplift and subsiding, so its general trend is parallel to horizontal axis. In other words, there are no accelerations and decelerations at R9 position, and its overall displacement rate is minor in comparison to other benchmarks, which is also apparent from the cumulative plot (Fig. 5). For this reason, R9 is not visualized in Fig. 6.

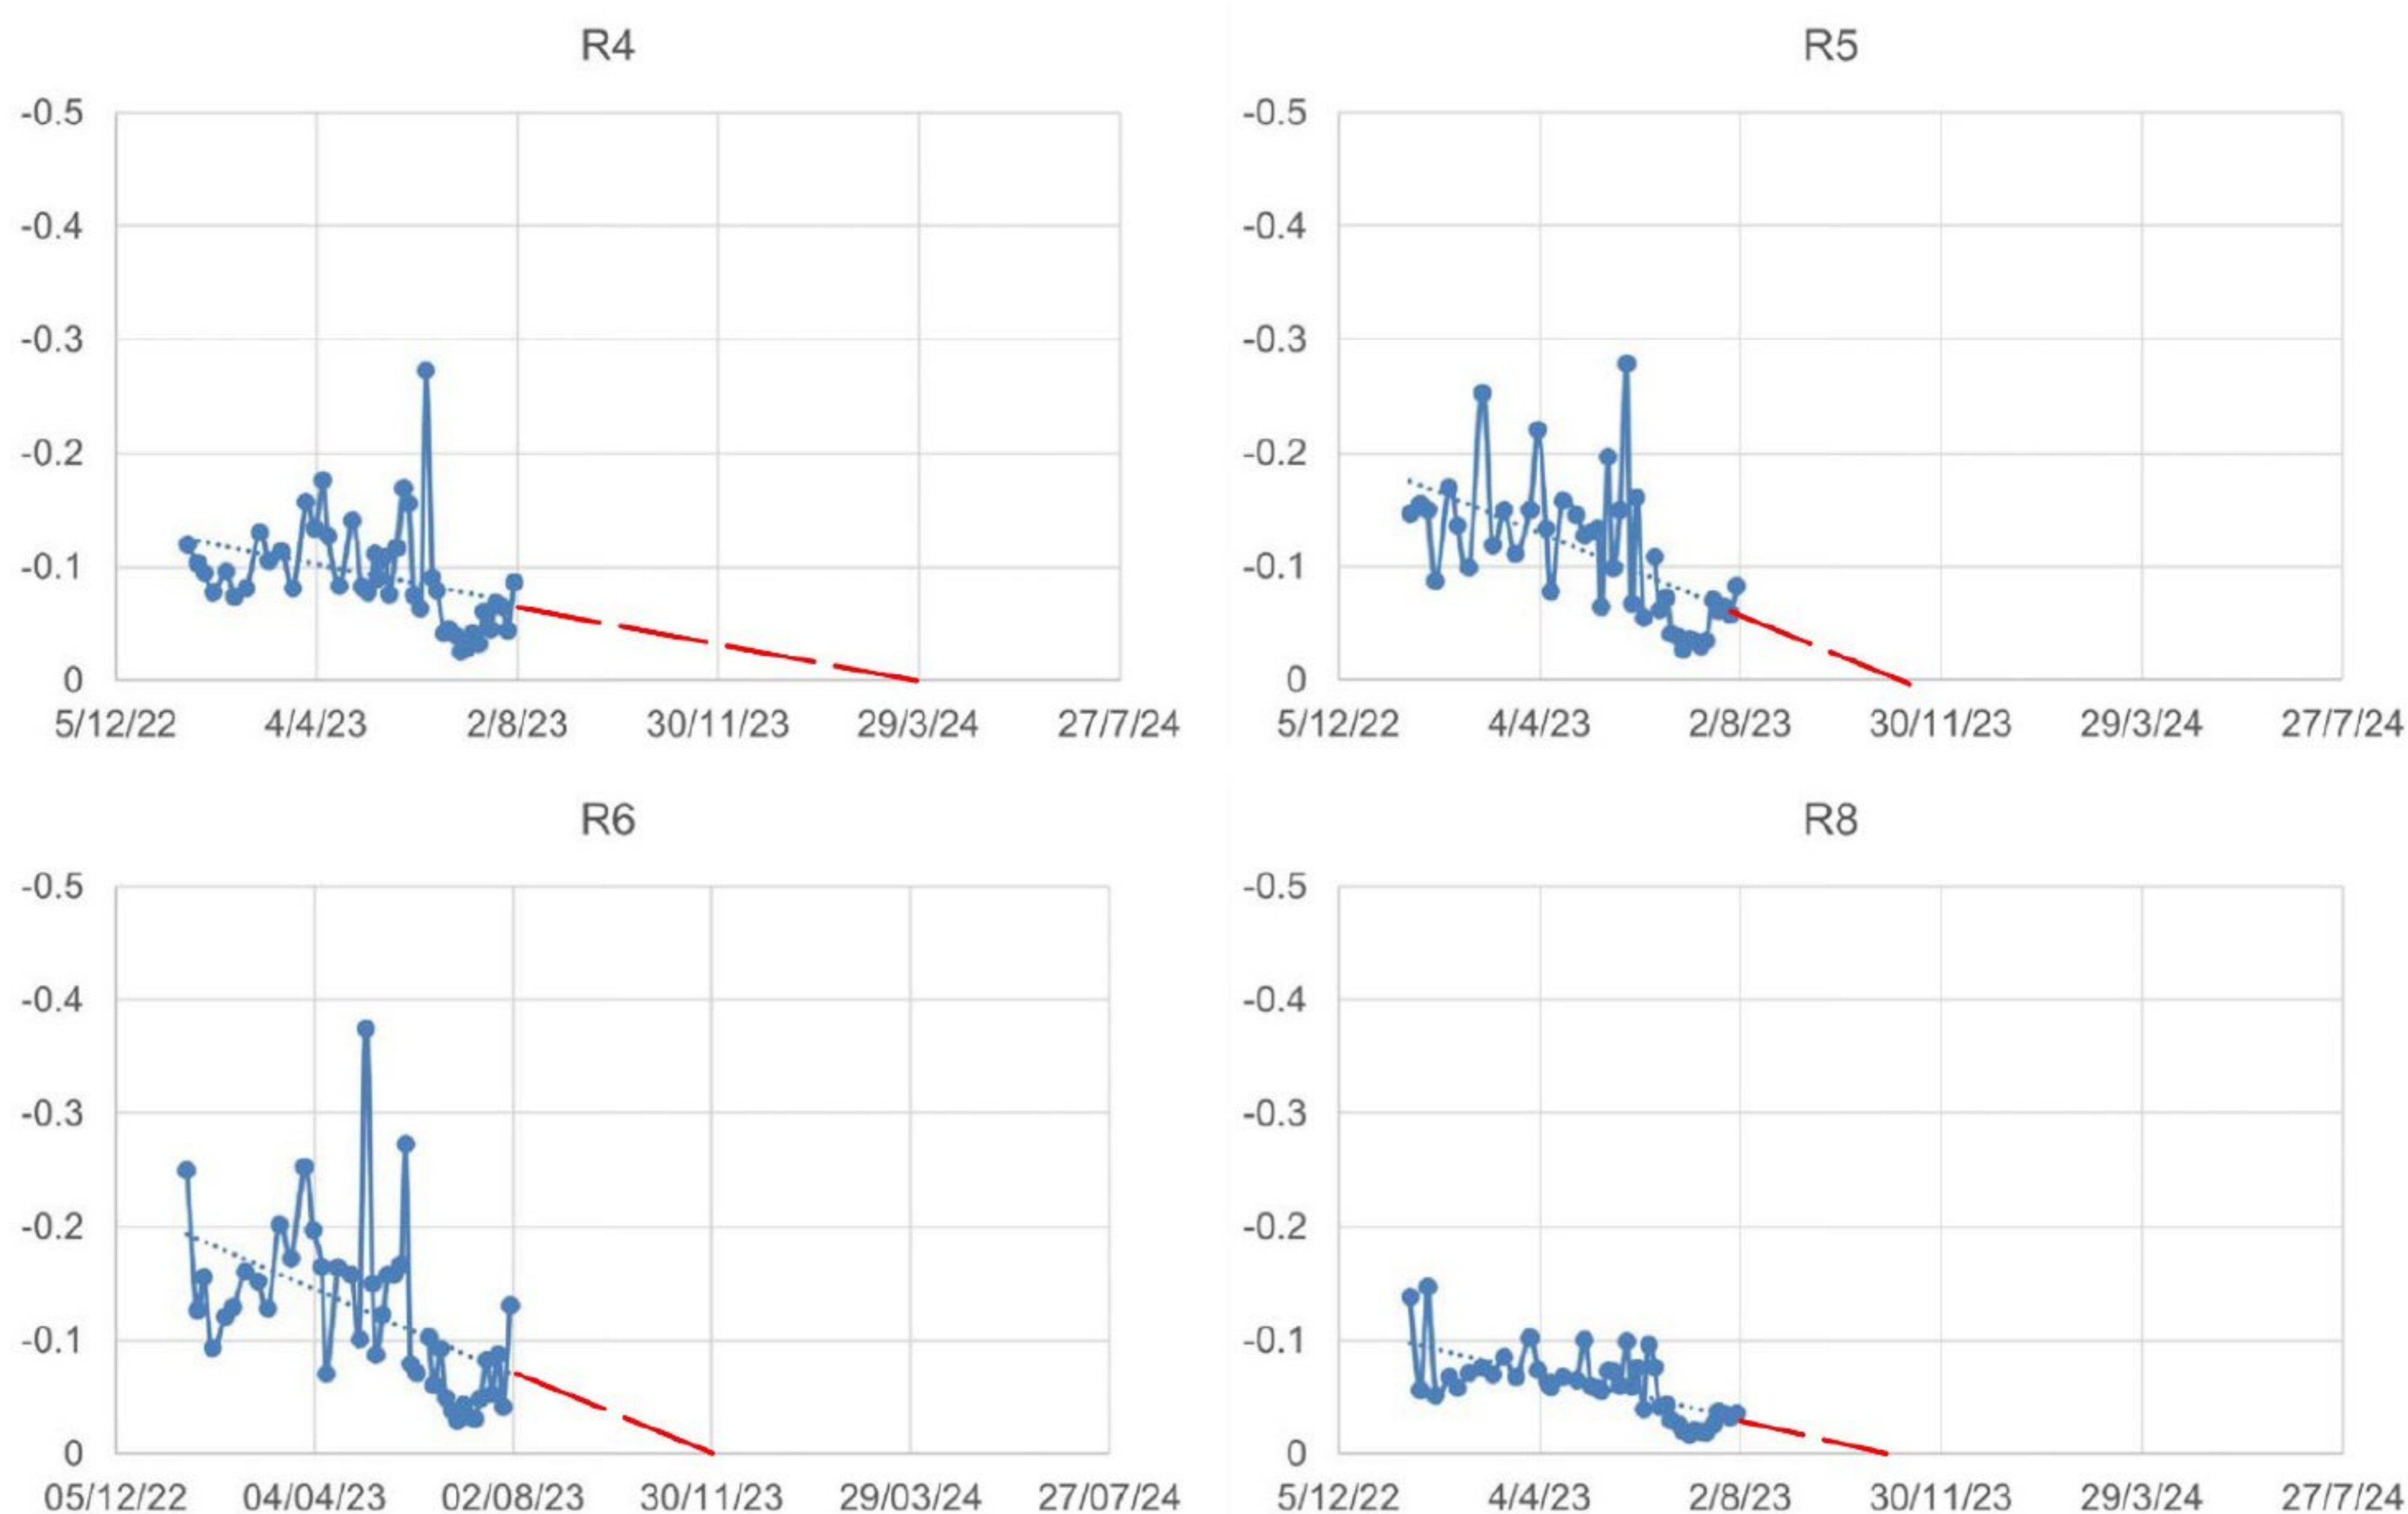
Figure 6 Inverse velocity plots of vertical displacements and extrapolated time of failure (red dashes).

All linear trends are calculated using least square method. Their linear extrapolations (Fig. 6) are not ideally aligned, but all indicate failure by the end of 2023 or beginning of 2024.

As the immediate measures were undertaken to prevent further displacement acceleration (including reshaping of the slope geometry and draining), this pessimistic estimation was luckily never confirmed, although it remains a big question whether the failure would follow the estimated linear trend or curve back upward and decelerate to a new steady state, as previously seen in some examples (Carlà et al., 2018). It is likely that a simple creep mechanism cannot entirely approximate the behaviour of a large rock slope, and that other complexities and additional factors were more influential than anticipated.
