Stability analysis on slope PK dacite Ceramide

Stability analysis on slope PK dacite Ceramide | Vladimir Čebašek, Veljko Rupar, Vladimir Ivoš, Vladimir Petković | VIII International geomechanics conference | 2018 | |

STABILITY ANALYSIS ON SLOPE PK DACITE ĆERAMIDE

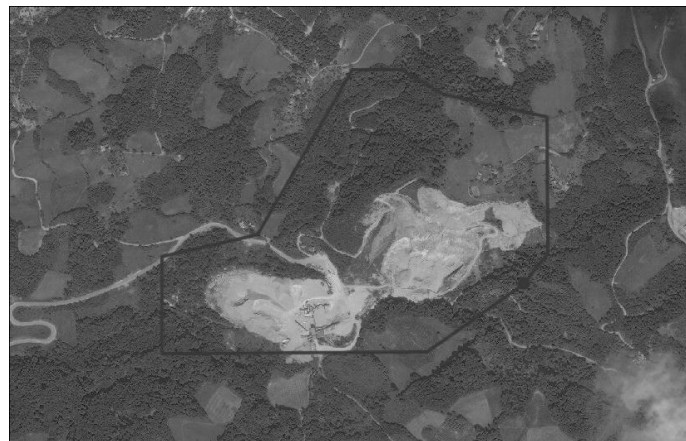
Figure 1. Exploitation field and open pit Ćeramide

Mining field Ćeramide, as well as the dacite open pit mine, is located in the Zagrađe village area, which belongs to the municipality of Gornji Milanovac. It is about 16 km away from Gornji Milanovac and the 3 km from small town of Rudnik. At about two kilometers a distance south of the deposit the main road Belgrade-Ćacak is located. Mining field Ćeramide covers an area of about 25.6 hectares.

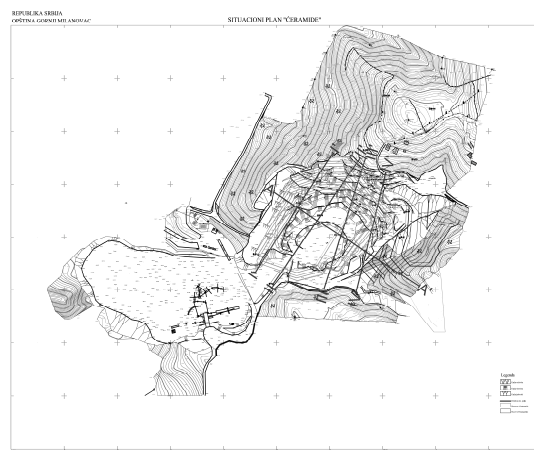
Figure 3. Representative cross-sections disposition at dacite open pit "Ceramide"

Dacite open pit slope design was carried out according to the previously shown results of benches and overall slope stability analyses. Designed open pit slope stability analyses was performed on five representative cross-sections: I-I', II-II', III-III', IV-IV' and A-A', which disposition is shown in Figure 3. Designed overall slopes are constructed in dacite rockmass. Slope stability analysis is carried out by finite element method. Appearance of analyzed cross-sections and the position of critical sliding zones are shown on Figures 4 to 8. [5]

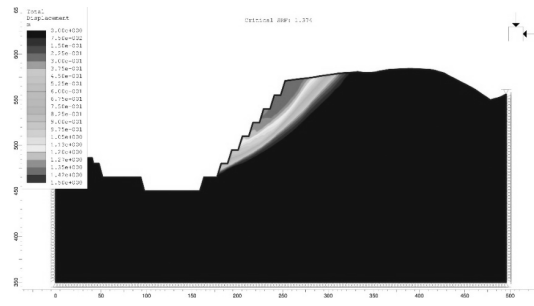
Figure 6. Appearance overall slope on cross-section III - III'

Position profile	Profile	Heigh slope H (m)	Angle of shear resistance α (°)	Safety factor F_s
Open pit	I – I'	120.87	52	1.749
	II – II'	105.00	55	1.437
	III – III'	120.87	52	1.374
	IV – IV'	76.57	50	1.651
	A – A'	61.67	53	1.671

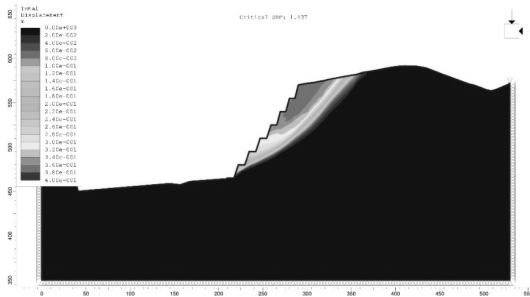
Figure 5. Appearance overall slope on cross-section II - II'

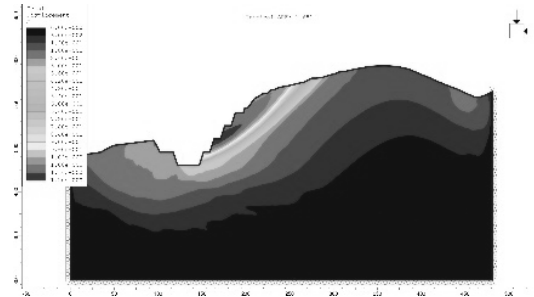
Figure 7. Appearance overall slope on cross-section IV - IV'
