*Original scientific paper*

## **2D GEOELECTRICAL RESISTIVITY TOMOGRAPHY APPLICATION AT THE FORMER CITY WASTE DUMP “ADA HUJA” – ECO - GEOLOGICAL PROBLEM**

**Branislav Sretenović<sup>1</sup>, Filip Arnaut<sup>1</sup>, Ivana Vasiljević<sup>1</sup>, Vesna Cvetkov<sup>1</sup>**

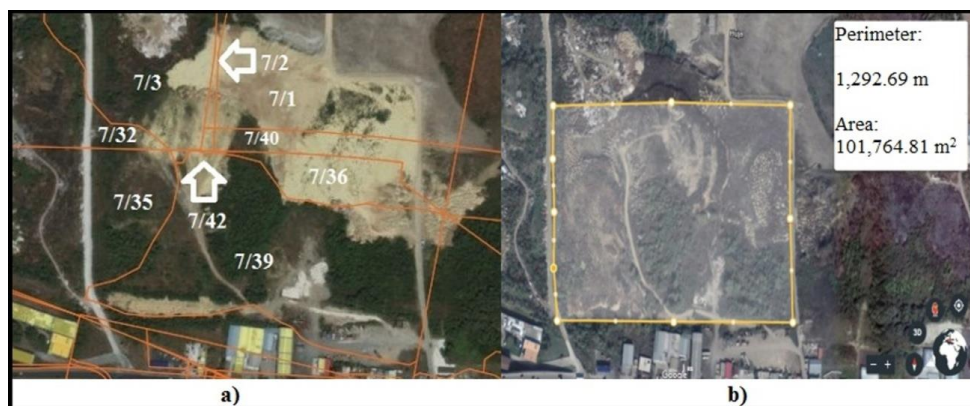
**Figure 10** Maps: a) Location of cadastre plots (National Spatial Data Infrastructure, 2019) and b) the real area of the surveyed terrain (Google Earth)

Plot areas should be taken with a reserve considering that they go out of the examined terrain, hence nobody can know for sure if the contaminated trend is maintained. Figure 10b shows the real area of the surveyed terrain and Figure 10a shows the cadastre plots of the terrain.

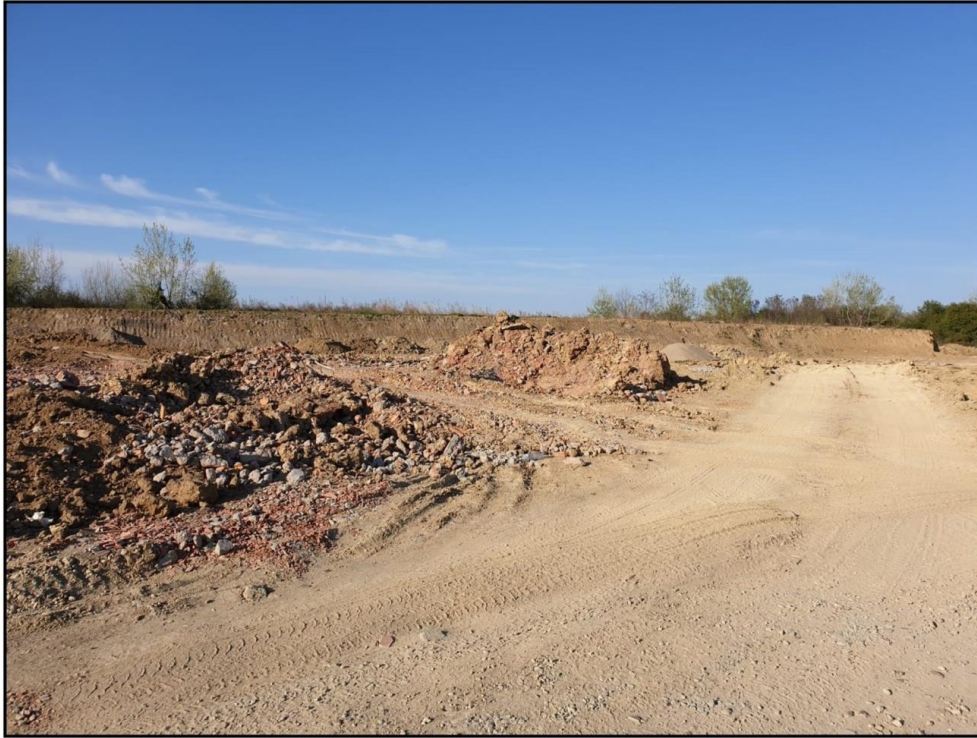
**Figure 11** Examined terrain photographed on 29<sup>th</sup> March 2019.

Visiting the examined terrain (Figure 11), it was quickly obvious that there is no indication of a Class I Forest.
